Heritage Statement 6 and 7 John Street, Bath BA1 2JL

December 2015

Kirsten Elliott
Historic Home Research
58 Minster Way
Bath BA2 6RL

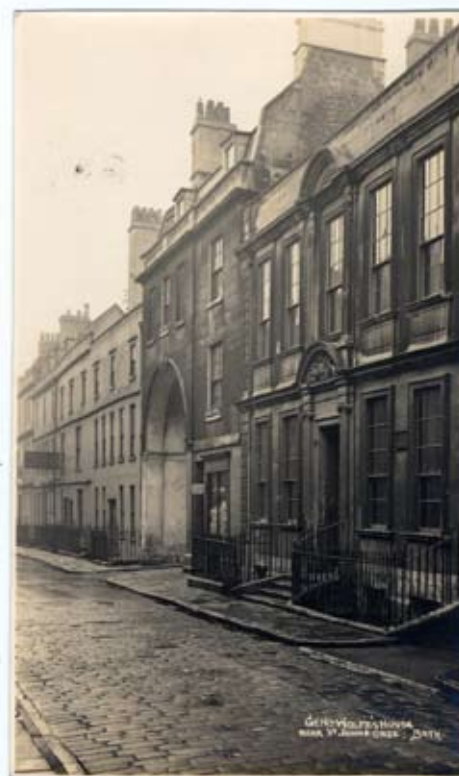
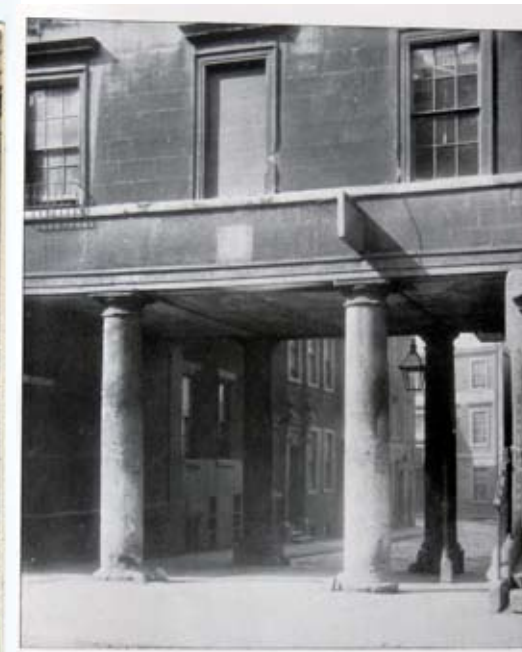
Above: St James's Portico, Pierrepont Street
Left: St John's Gate, as it was before the demolition of the adjacent house in Trim St.

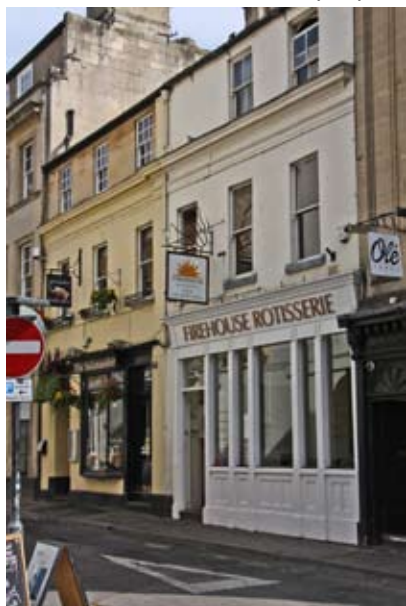
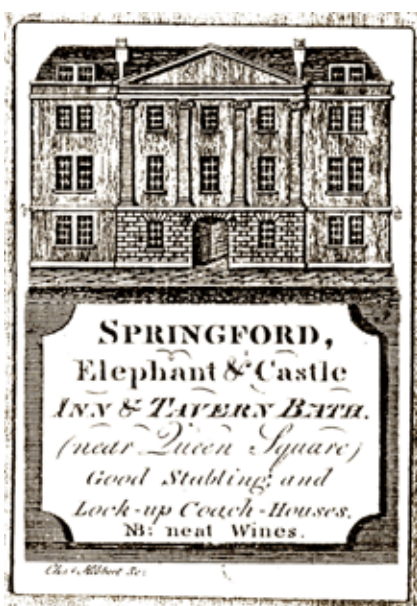
Far Left: Nos. 2 and 3 which may be Wood's samples, though altered in the 19th century.

Left: The Elephant and Castle, formerly Jennings stables, in Monmouth Street, possibly by Wood.

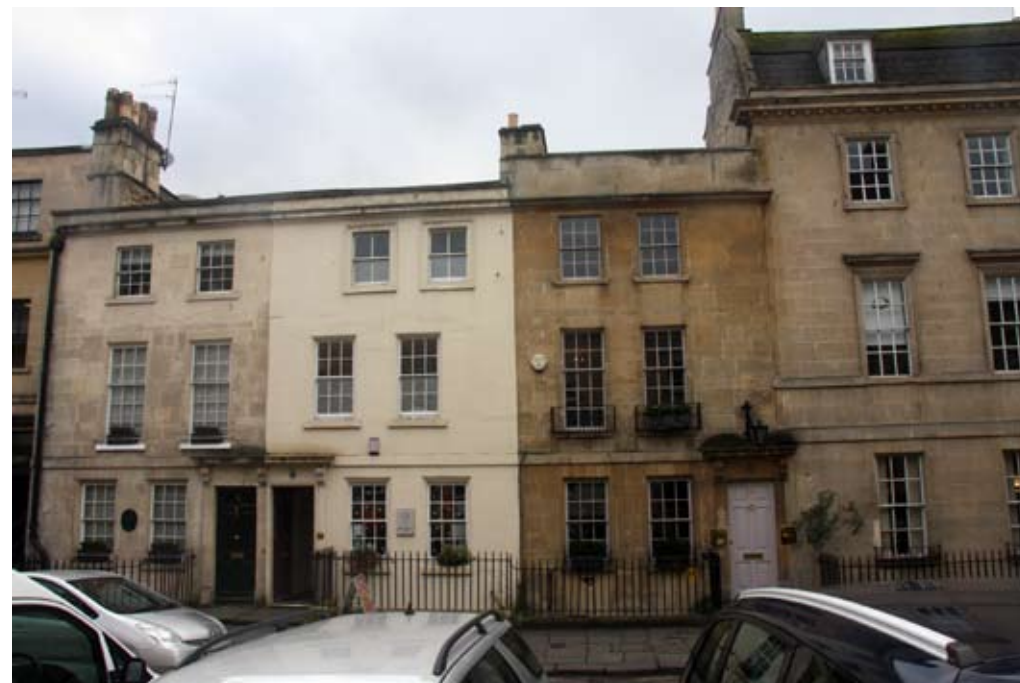
Above: Irregularity and lack of symmetry in the houses in Old King Street, suggesting that these are not by John Wood. For comparison, the one on the extreme right is one of Wood's, in Queen Square.

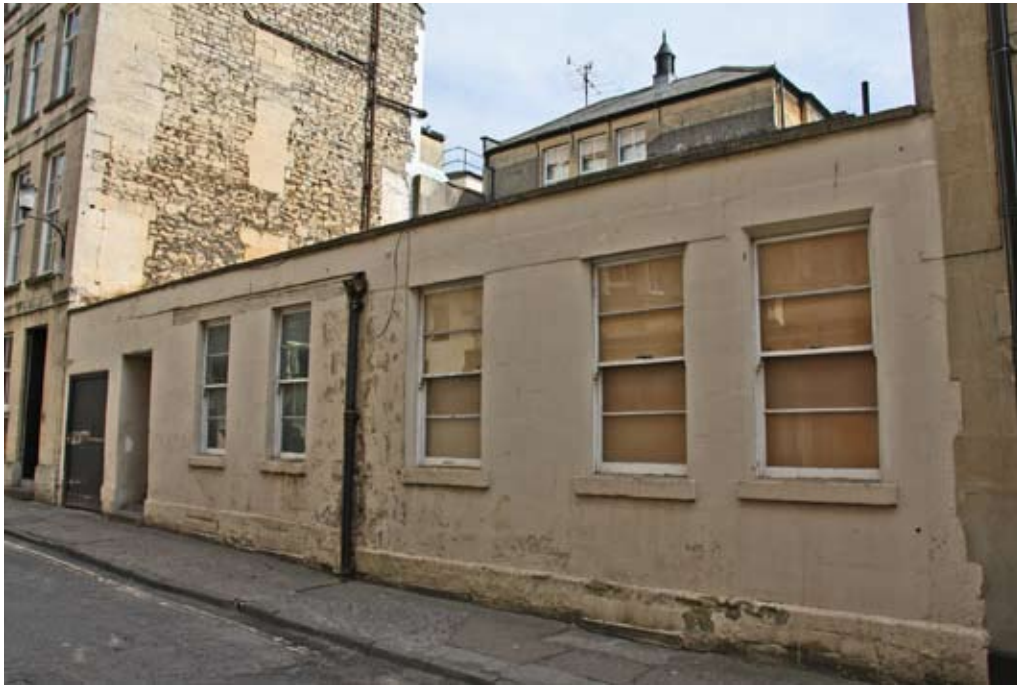
Above: the present façade of Nos. 6 and 7 showing the revealed bressumer over No. 7 and the still hidden but faintly visible bressumer over No. 6.

At Nos. 6 and 7, John Street, each has a bressumer – that sure sign of Georgians building on the cheap. At No. 6, it still retains its lime render cover coat, but it is clear that one is lurking underneath. John Wood always demanded high standards of his builders, so this must rule them out as having been built by him. We know he let off plots to other builders and developers, and this is what seems to have happened here.

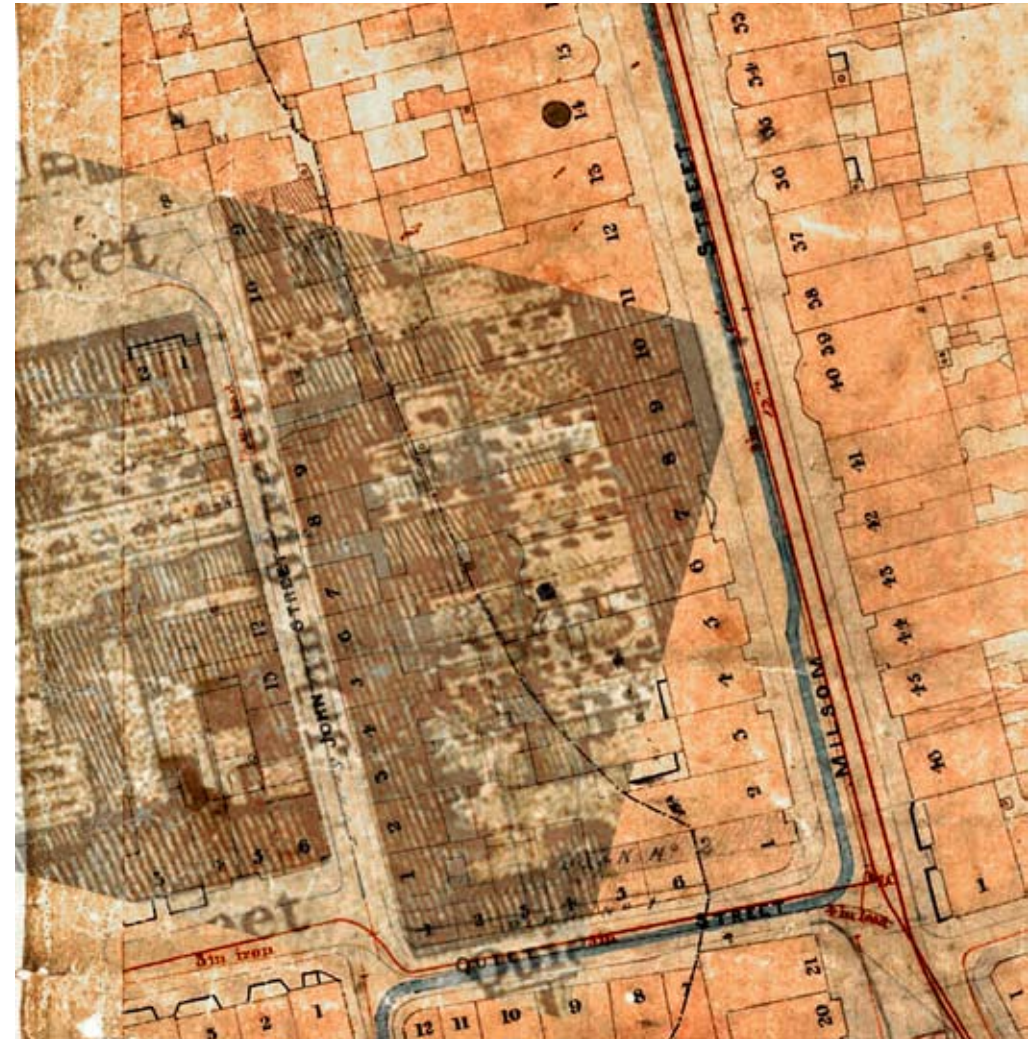
Above: 1803 map by Harcourt Masters (brown shading) imposed on 1852 Spackman and Cotterell Survey of Bath. For separate maps, see the end of this section.

There were buildings on the site of the 1882 extension to Jolly's, probably farm buildings or perhaps stables. The Davis Tudorbethan extension and the present No 10 stand on the site of the gap. The east side ran up in a solid block to and including the present No. 9. This is at the back of No. 10 Milsom Street, and is where John Plura once had his Great Room for auctions. The present south side of No 8 shows what was probably the party wall of the old No 8, and what look like blocked windows are in fact blocked chimney places for the adjoining house – which is no longer there. It was standard Georgian building procedure, when building a party wall, to construct the gaps for the fireplaces, so that they could share the flue. No 8 has a chimney stack, and there are the remains of stacks inside the building where fireplaces have been removed. This means that there was an adjoining house. We can also tell how high it was and its floor levels.

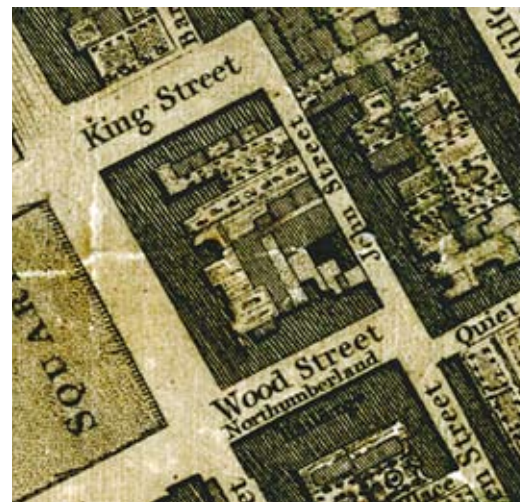
Above: 1803 Harcourt Masters

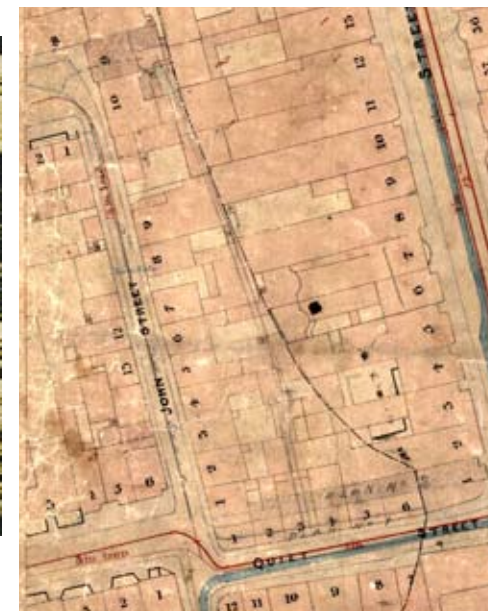
Right: 1852 Spackman and Cotterell

Had the gap between 7 and 8 remained as an archway, it would be marked as a building with a cross from corner to corner on both the 1852 and 1886 maps, to indicate that it was an arch. But both show it as a clear gap.

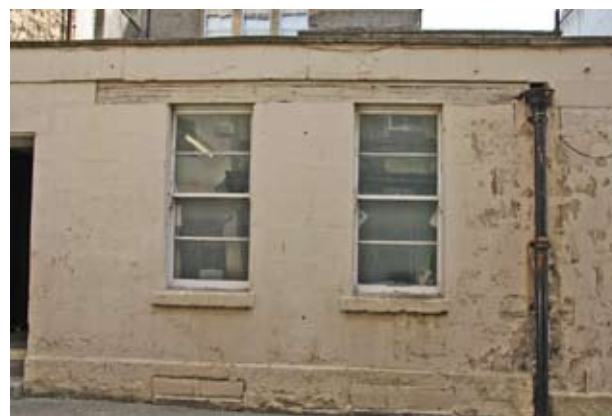
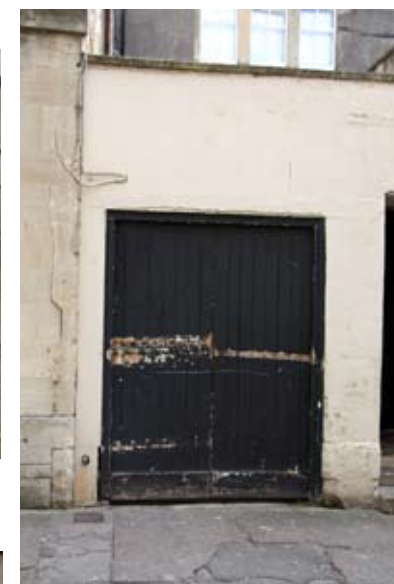
Left: No. 7 (above) and No. 6 (below).

From the street, there is little to see. The two houses are now just a single storey, of ashlar single block construction with a bressumer above the windows. The windows are Victorian sashes with horns. No. 6 has a blocked doorway converted to a window – as this is a Victorian sash it appear likely this was done in the late nineteenth century during the alterations by R King, when their premises were extended in 1892. They did not own No. 6 in the 1870s, as their advertisements make clear. The entrance to the passageway between 7 and 8 is now blocked by a door. No. 7 has a deeply recessed doorway.

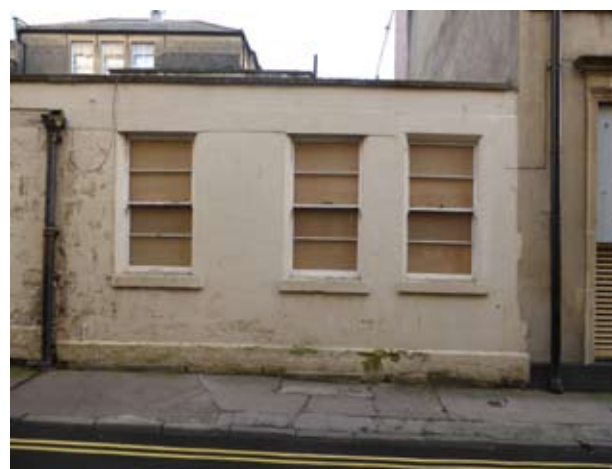
Above: Entrance way to gap (now covered) between 7 and 8.

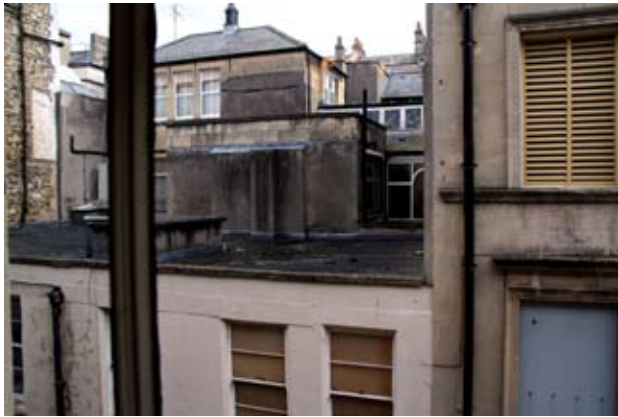
Left: Roofscape of Nos. 6 and 7 seen from the shop opposite (Mr B's Reading Emporium.)

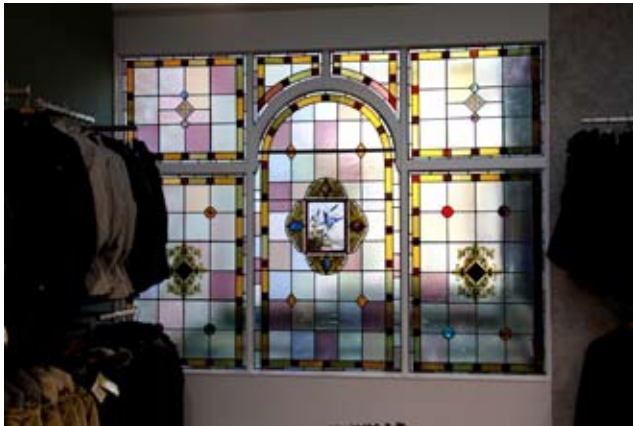
Left: This is the window which can just be seen in the picture above from inside the Milsom Street shop.

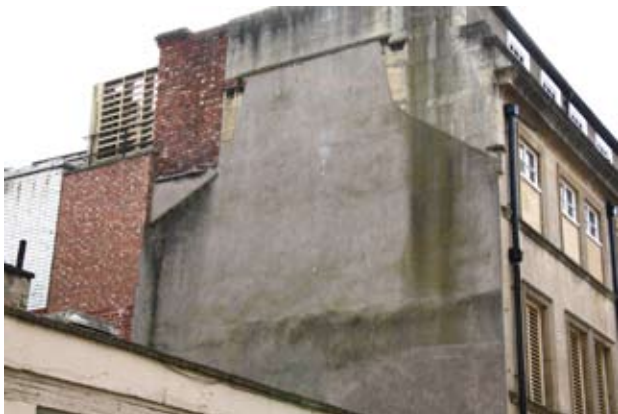
Left: The 'ghost' of No. 6 left on the wall of No. 5.

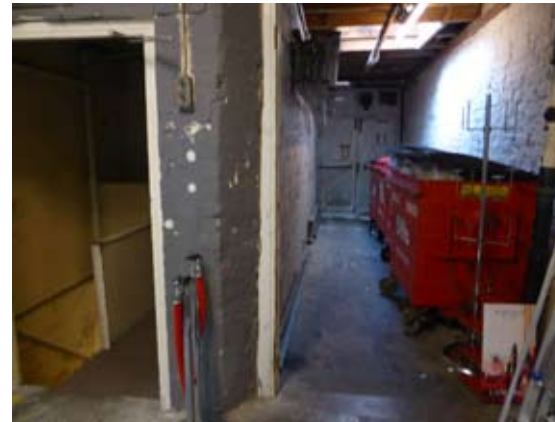
Left from top: Rear and side wall of No. 7; side wall of No. 7; passageway. Right from top: Chamfer on King's Arms; the building; the passageway.

The passageway between 7 and 8 is paved. The corner of No. 7 is chamfered and this is further evidence that there were stables at the back. In Broad Street, the former Kings Arms (which now has Robert Walsh's shop on the ground floor) has a similar passage to the rear, where the stables now form part of Côte Brasserie. The inn building also has a chamfered corner, to allow coaches to negotiate the tight turn. (See photos in section 3.1.2.) However, the one in John Street shows sufficient marks to suggest that not everyone managed it without bumping into the wall.

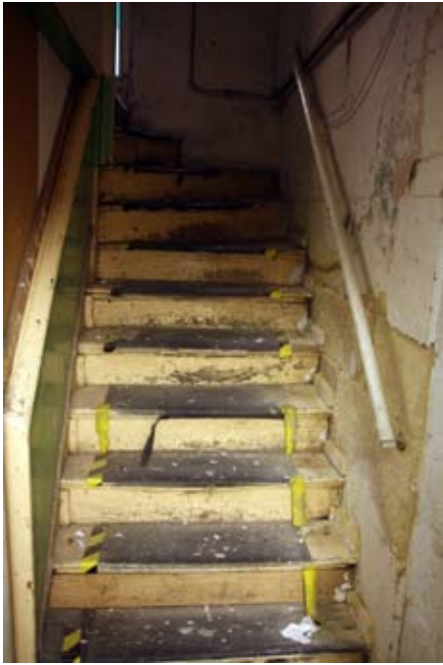
Above left: staircase with modern nonslip treads.

A steep staircase gives access to the cellars. This is wooden, but modern nonslip treads have been put on top, and the treads now feel suspiciously spongy. If these are original, they may be beyond repair – the treads need to be removed to investigate.

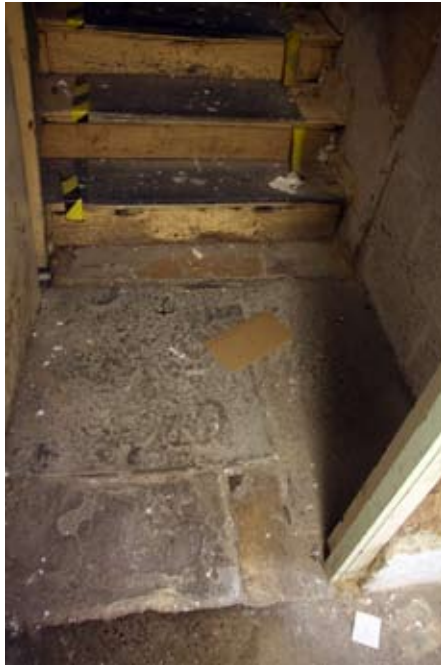
Above right: At the foot of the stairs there are old flagstones. This picture also shows where an old doorway at the foot of the stairs has been filled in with blockwork and a new doorway created.

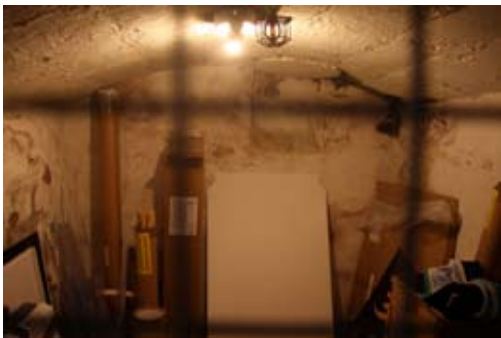
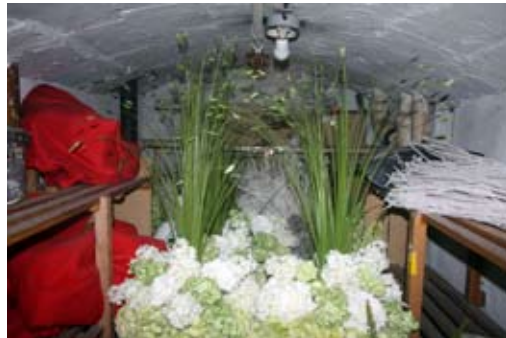
Above: two of the vaults. That on the left has the remains of a coal hole.

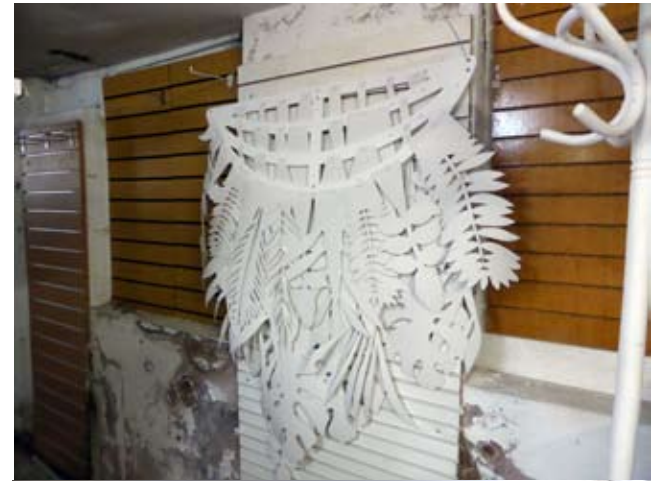
Right: Front wall of No. 7 in the cellars, showing blocked area windows, and damp breaking through.

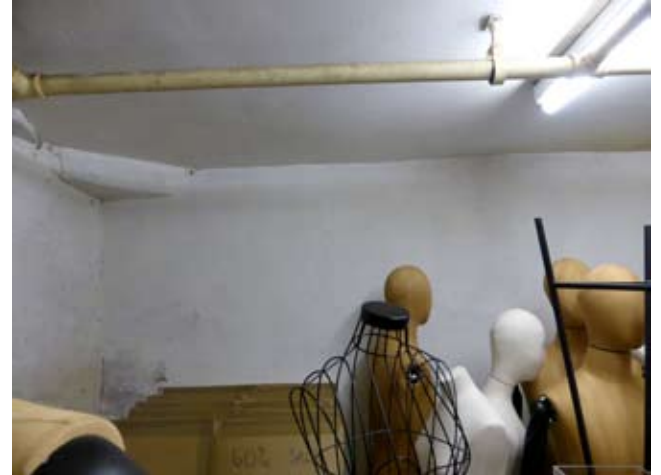
Right: Back wall of No. 6 in the cellars, showing smooth Vandex covering on back wall. Note further pipework.

In both sets of cellars, interior walls survive. The back wall of No. 8 is suspiciously smooth – it may just be caused by the Vandex coating, but that in itself suggests there have been further issues with damp. It may indicate that the wall has been rebuilt or substantially repaired. Investigation would reveal what has happened. The stairs are missing in No. 6 though the stairwell is identifiable. Here, the back wall is definitely blockwork. Various services – pipework, electric cables, etc, have been pushed through or suspended from the ceiling

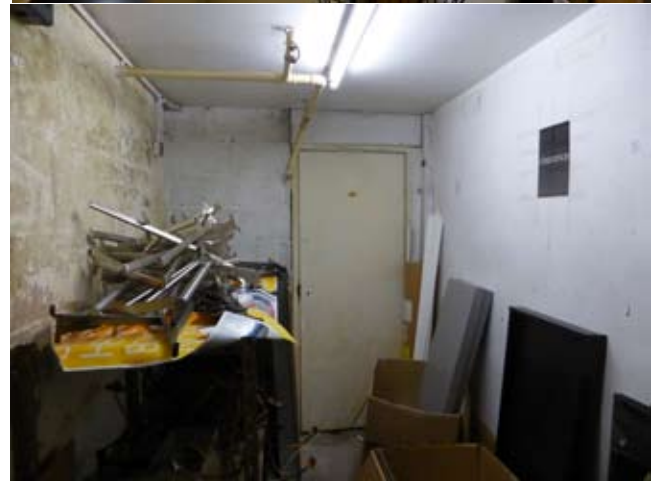
Right: back wall of No. 6 in the old stairwell. Here it can be seen the back wall is definitely blockwork.

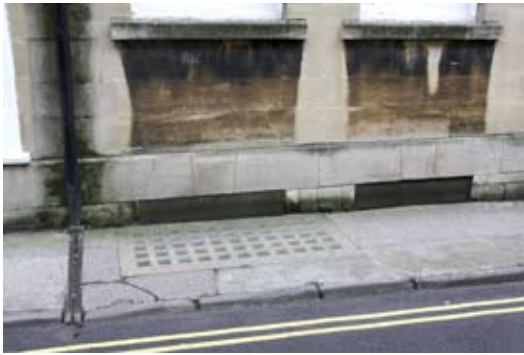
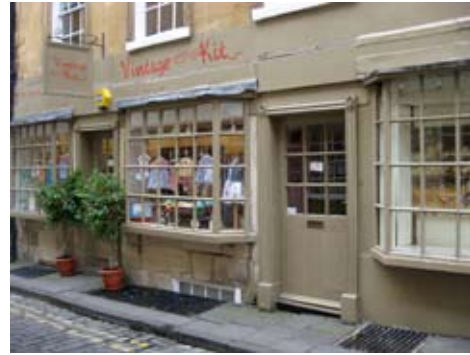
Above left: Glassblocks above former area outside No. 8 John Street.
Above right: grills above the areas in Queen Street.

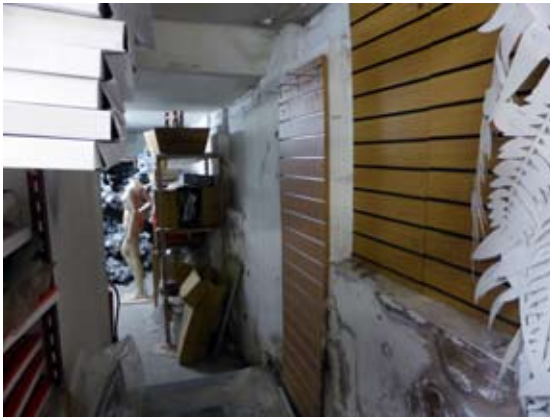
Left: view through from 7 to 6, showing drop and width of party wall.
Below: the width of the party wall.

It soon becomes apparent that the houses were at slightly differing levels – there is a step down both here in the cellar and on the ground floor into No. 6. This is not so obvious from the outside.

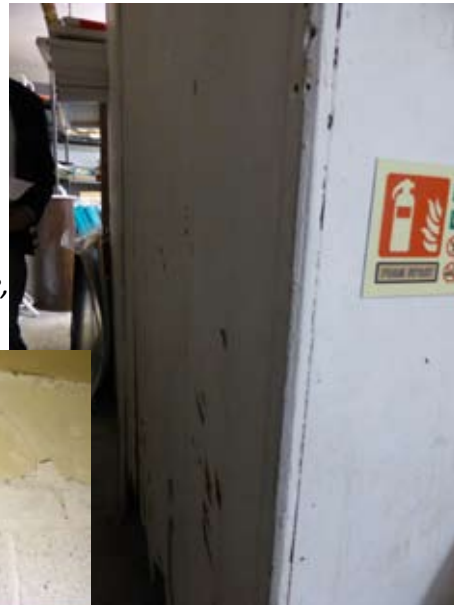
Below: typical mixture of original stone, block and pipework at this level.

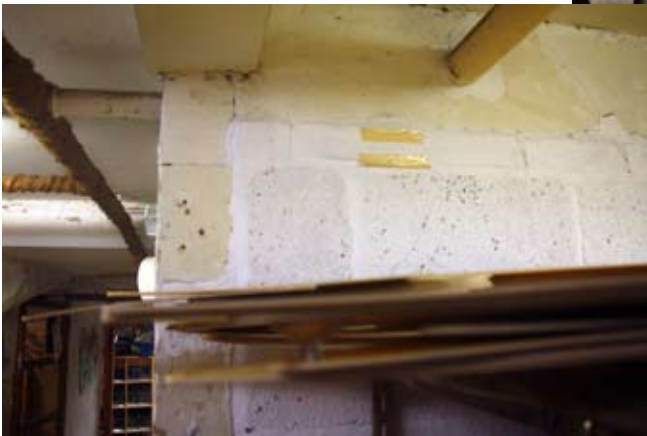
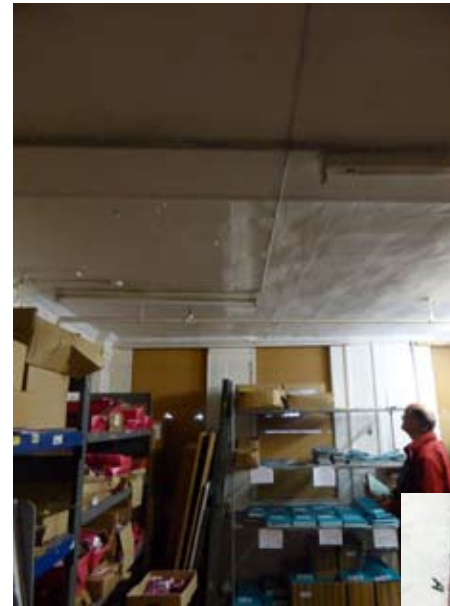
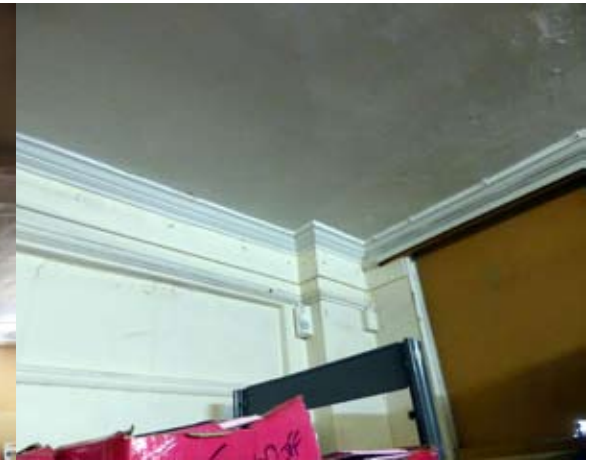
Top left: Ground floor in No. 6 looking west, showing marks of old walls on the ceiling. The left hand present window would have been the doorway.
Top right: The best remaining section of cornice and panelling, though damaged by trunking to protect wiring.
Middle: plan of Nos 4 and 5 but with hallway of No. 6 just indicated.

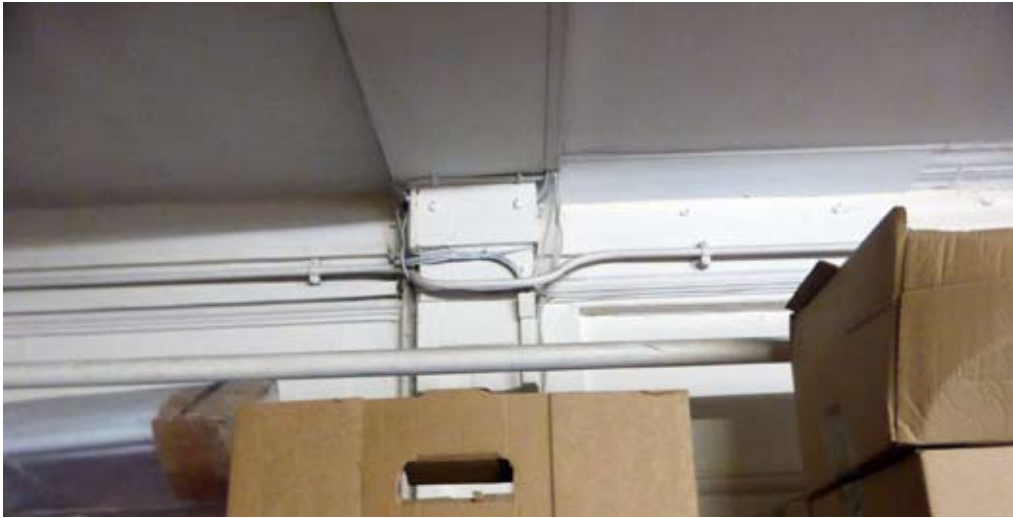
Above: a view at cornice level of what would have been the hallway and probable archway in front of the stairs. To the right, it can be seen that the cornice is missing as it approaches the site of the archway, and it does not continue after it. Cabling and pipework intrude here too.

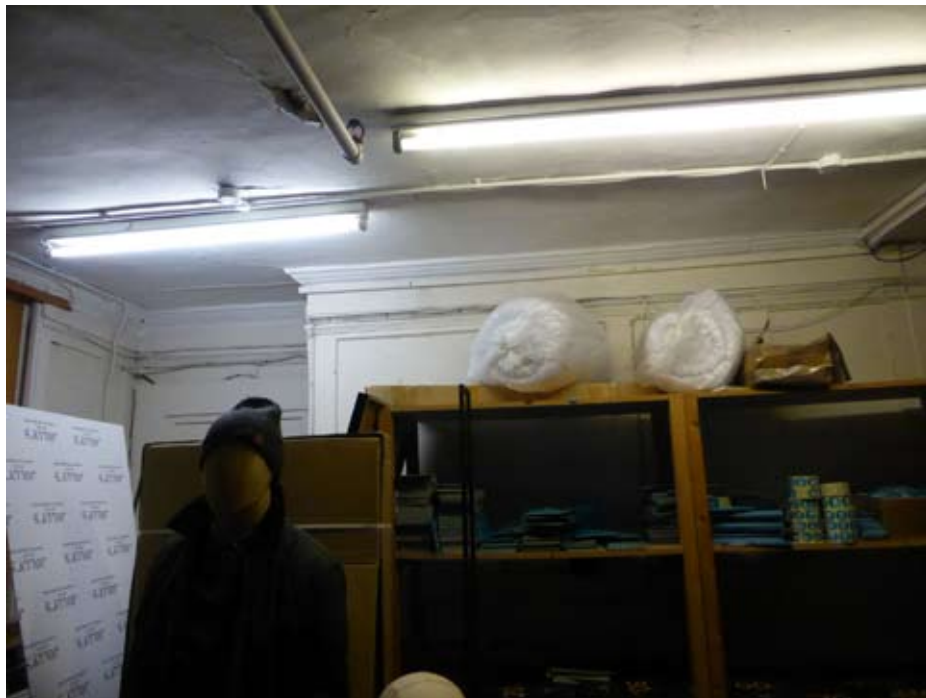
Above: detail of cornice above chimney stack, and panelling. Modern dado rail has been added to panelling - visible beneath wiring.

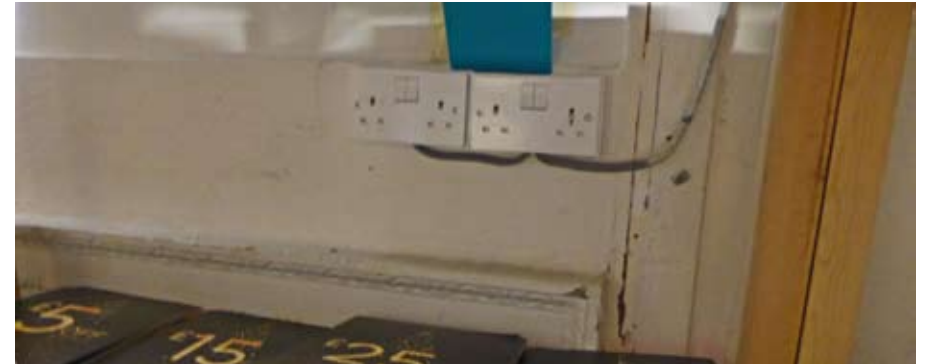
Above: all that can be seen of the stone fire surround just visible at the bottom.

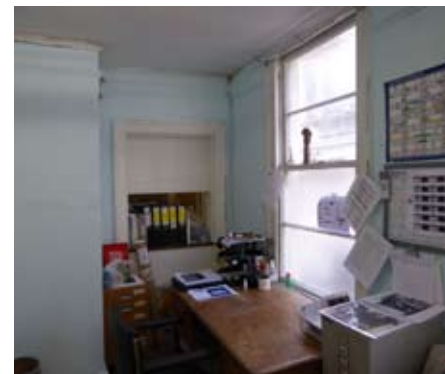
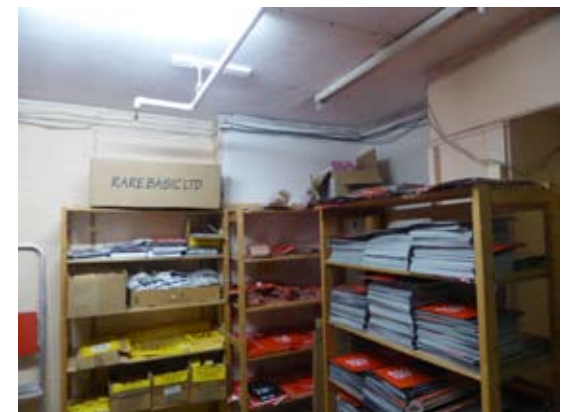
Below: two views of No. 7. To the left is the front office, with a window pushed through the party wall into No. 6.

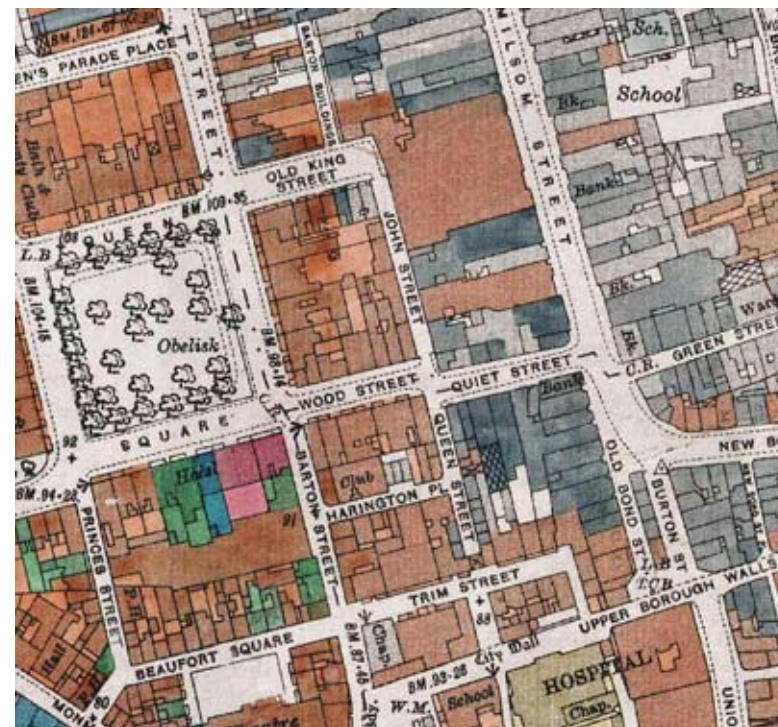
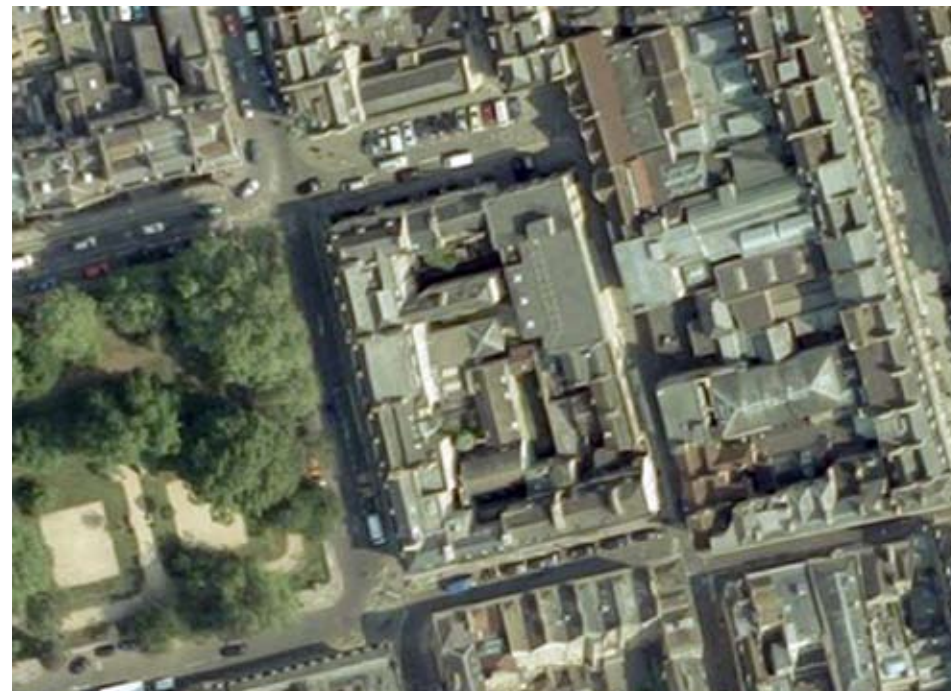
Insurance maps corrected to 1954 (above) and 1958 (below) showing alteration in height.

Above: Bomb damage map showing Nos. 6 and 7 only suffering damage to glass.

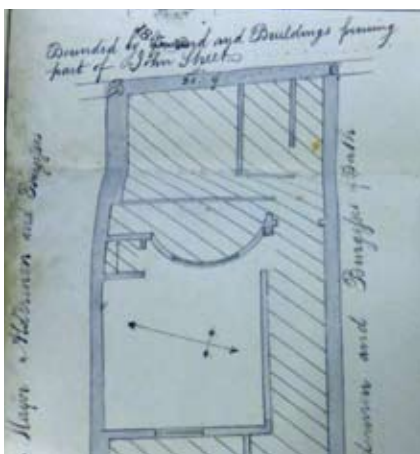
Plans from leases of 1839, 1842 and 1973 showing John Street properties as legally distinct from Milsom Street properties.
